Flood Control Project Maintenance
2019 Structure Summary Report
Overall Unit and Item Ratings

Lower San Joaquin Levee District

Ash Slough Drop Structure No. 1

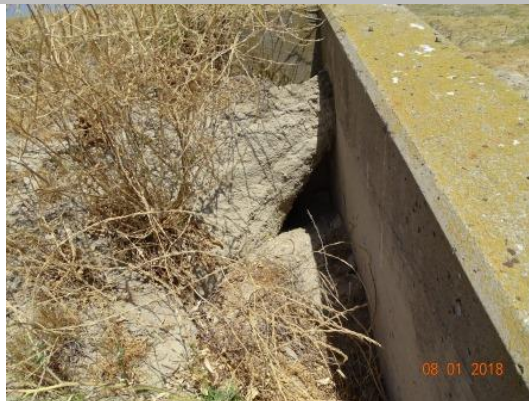
Photo 2 of 3 : ST_2019_NA0010_24_4_20190613_00005.jpg

LM Start	0.00	Rating **	M	Issue No.	4 (cont)	
LM End	0.00	Issue Type +	Ma	Location *		
Category	Structures & Concrete Lined Channels			GPS Latitude/Longitude		
				Start	End	
Item	Erosion / Bank Caving			37.033952 °	37.033952 °	
				-120.441733 °	-120.441733 °	
DWR ID	DWR_NA0010_24_t_2017_4					
Action/Comments						
Inspector Comments: Some minor erosion or animal burrowing was found on the back side of the right wing wall of the structure. Rock along the downstream edge of the structure has been washed away.

Minor erosion at right wing wall (2018)

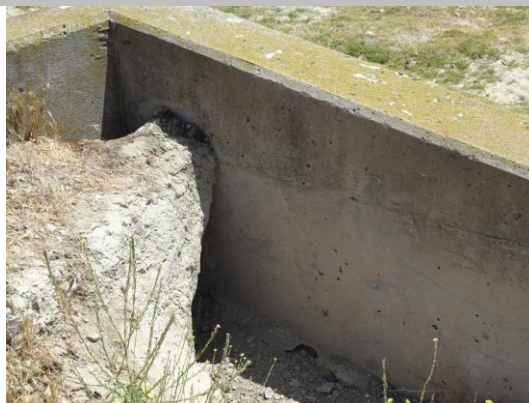
Photo 3 of 3 : ST_2019_NA0010_24_4_20190613_00007.jpg

Ash Slough #1 minor erosion at right wingwall. (Summer 2017)

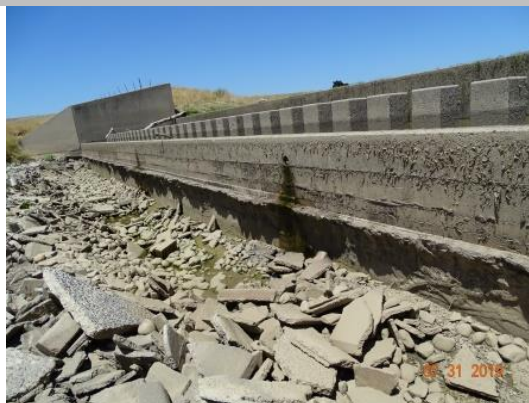
Photo 2 of 3 : ST_2019_NA0010_24_5_20190807_00020.jpg

LM Start	0.00	Rating **	U	Issue No.	5 (cont)	
LM End	0.00	Issue Type +	Ma	Location *		
Category	Structures & Concrete Lined Channels			GPS Latitude/Longitude		
				Start		End
Item	Revetments			37.033952 °		37.033952 °
				-120.441733 °		-120.441733 °
DWR ID	DWR_NA0010_24_t_2012_5					
Action/Comments						
Inspector Comments: Downstream revetment has been washed away from the structure and should be replaced.

Downstream revetment has been washed away. (2019)

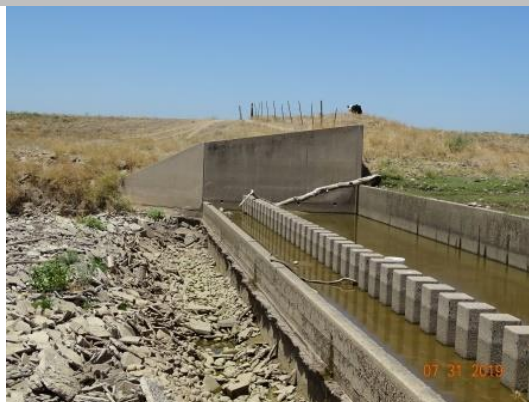
Photo 1 of 1 : ST_2019_NA0010_24_17_20190807_00022.jpg

LM Start	0.00	Rating **	M	Issue No.	17
LM End	0.00	Issue Type +	Ma	Location *	
Category	Structures & Concrete Lined Channels	GPS Latitude/Longitude			
		Start		End	
Item	Concrete Foundations	37.033952 °		37.033952 °	
		-120.441733 °		-120.441733 °	
DWR ID	DWR_NA0010_24_t_2012_17				
Action/Comments					
Inspector Comments: Erosion and revetment displacement at base of downstream side of structure.

Erosion and revetment displacement at the base on the downstream side of structure. (2019)

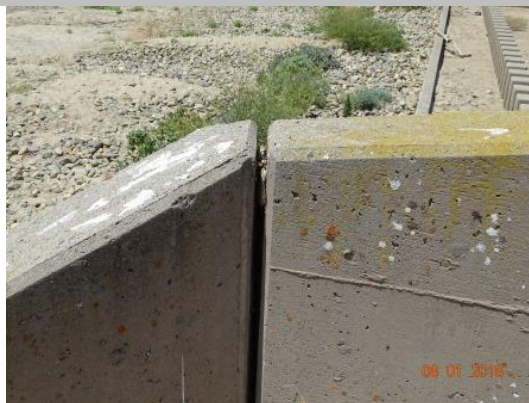
Photo 1 of 1 : ST_2019_NA0010_24_22_20190613_00010.jpg

LM Start	0.00	Rating **	A	Issue No.	22
LM End	0.00	Issue Type +	Ma	Location *	
Category	Structures & Concrete Lined Channels			GPS Latitude/Longitude	
				Start	End
Item	Monolith Joints			37.033952 °	37.033952 °
				-120.441733 °	-120.441733 °
DWR ID	DWR_NA0010_24_t_2012_22				
Action/Comments					
Inspector Comments: Joint gaskets on the left bank appear to be deteriorating. Monitor for potential repairs.

Left bank joint deteriorating. (2018)

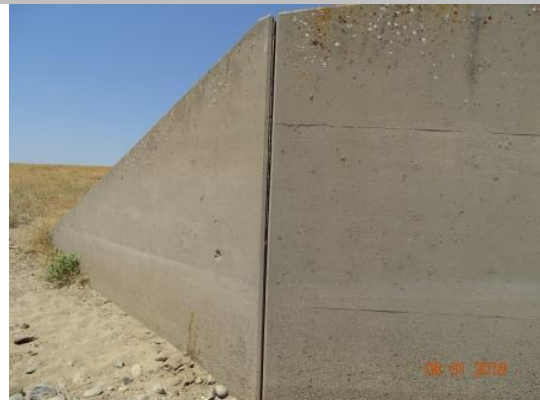
Photo 1 of 4 : ST_2019_NA0010_25_22_20190613_00011.jpg

View of monolith joint at right wing wall (2018)

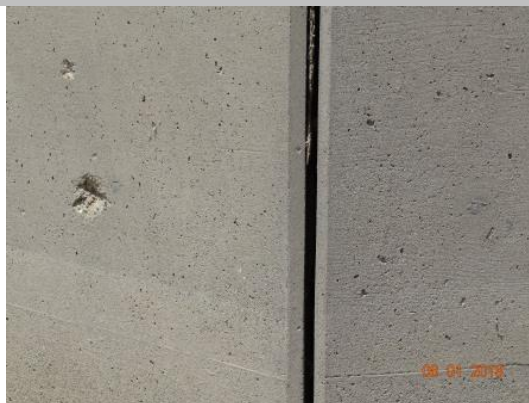
Photo 2 of 4 : ST_2019_NA0010_25_22_20190613_00012.jpg

Upclose view of monolith joint at right wing wall (2018)

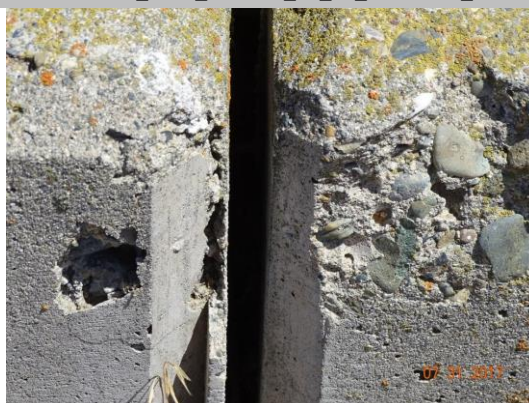
Photo 3 of 4 : ST_2019_NA0010_25_22_20190613_00013.jpg

Left bank gasket is deteriorated at headwall. (2017)

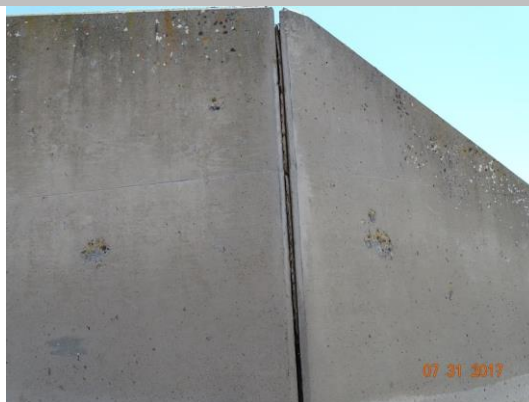
Photo 4 of 4 : ST_2019_NA0010_25_22_20190613_00014.jpg

Gasket is deteriorated on the wingwall left bank. (2017)

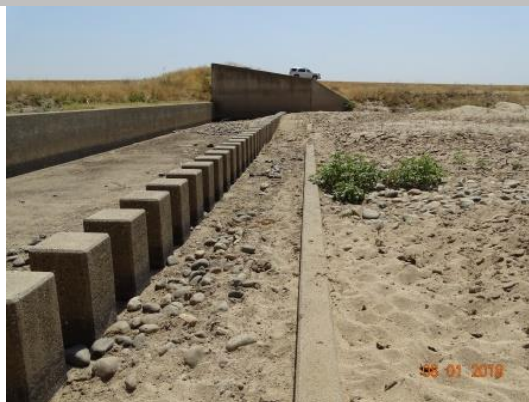
Photo 1 of 2 : ST_2019_NA0010_26_5_20190613_00007.jpg

Downstream view of revetment, mostly obscured by sedimentation (2018)

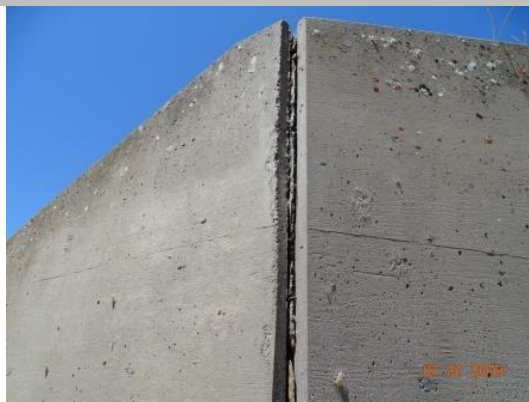
Photo 1 of 2 : ST_2019_NA0010_26_22_20190807_00018.jpg

Deterioration of right wing wall gasket. (2019)

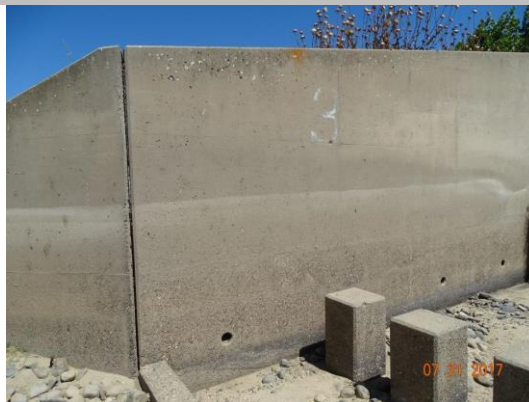
Photo 2 of 2 : ST_2019_NA0010_26_22_20190613_00009.jpg

View of the right wingwall joint. The gasket has deteriorated midway down the joint. (2017)

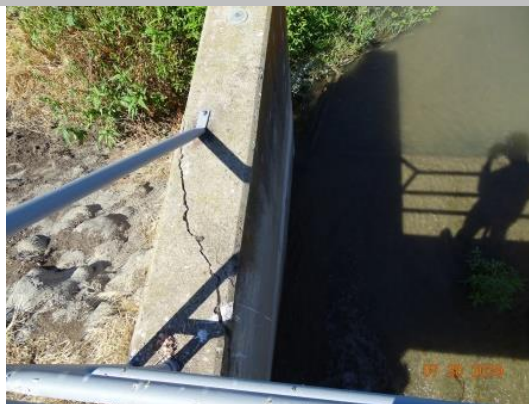
Photo 1 of 3 : ST_2019_NA0010_34_15_20190802_00023.jpg

Cracking on left wing wall. (2019)

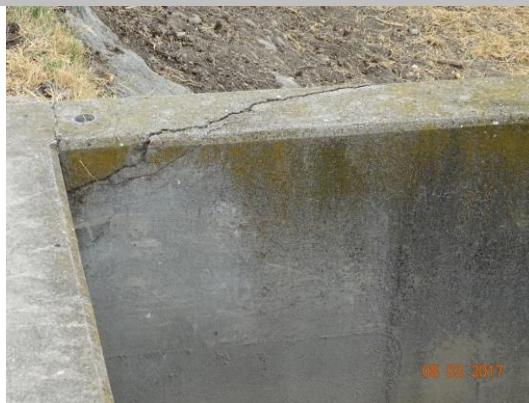
Photo 2 of 3 : ST_2019_NA0010_34_15_20190613_00012.jpg

Cracking on left wing wall. (2017)

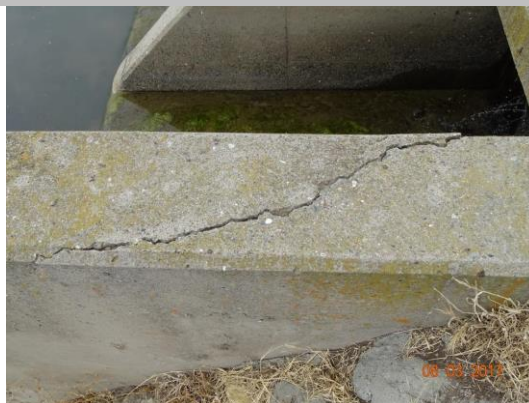
Photo 3 of 3 : ST_2019_NA0010_34_15_20190613_00013.jpg

Cracking on left wing wall. (2017)

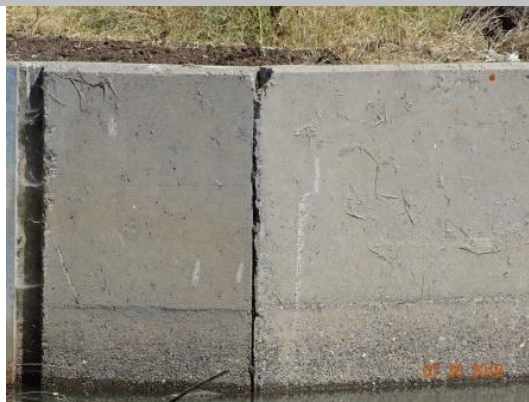
Photo 1 of 1 : ST_2019_NA0010_34_22_20190802_00024.jpg

Joint deterioration on right headwall. (2019)

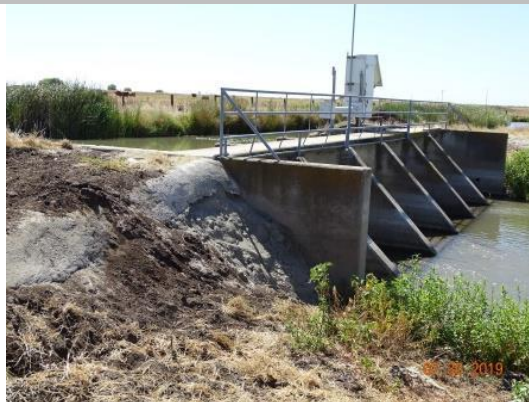
Photo 1 of 1 : ST_2019_NA0010_34_23_20190802_00025.jpg

Handrail added to downstream side of structure. (2019)

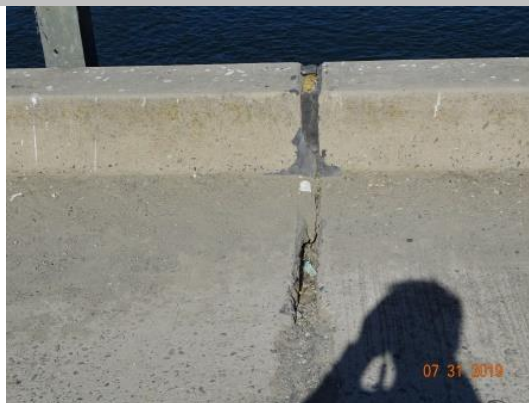
Photo 1 of 2 : ST_2019_NA0010_65_22_20190806_00019.jpg

Deterioration of joint material along top on roadway side of structure.
(2019)

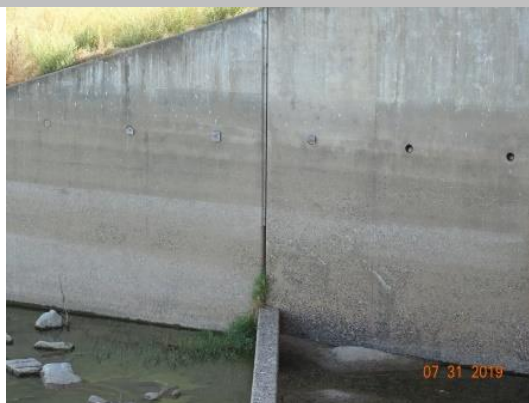
Photo 2 of 2 : ST_2019_NA0010_65_22_20190806_00020.jpg

Minor deterioration and vegetation growth in joint on right wing wall.
(2019)

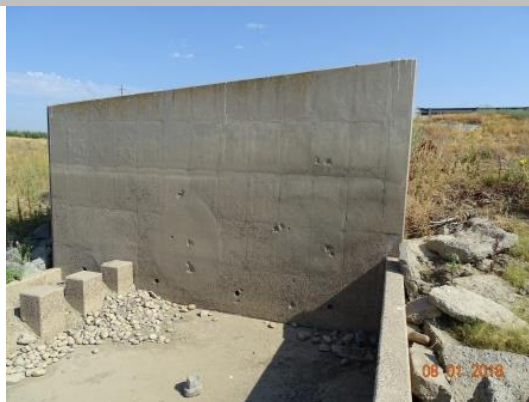
Photo 1 of 3 : ST_2019_NA0010_29_15_20190613_00012.jpg

Minor spalling on right wing wall (North side) (2018)

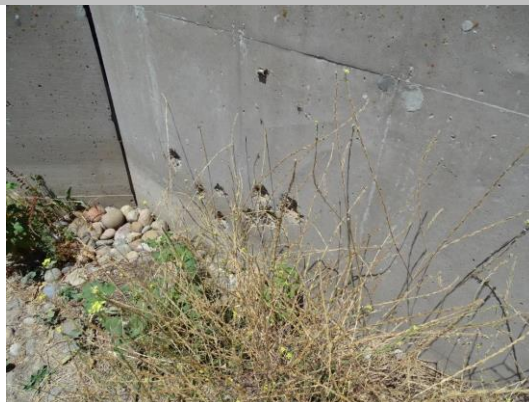
Photo 2 of 3 : ST_2019_NA0010_29_15_20190613_00013.jpg

Minor spalling on left wing wall (South side) (Summer 2017)

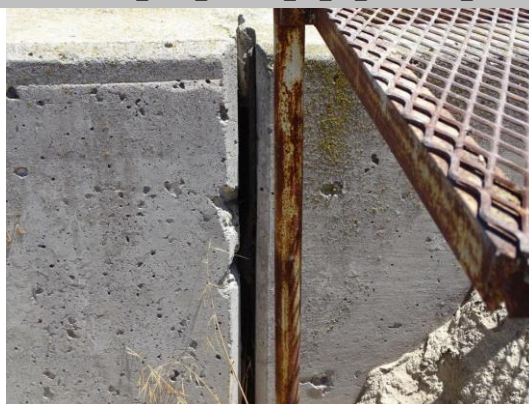
Photo 1 of 4 : ST_2019_NA0010_29_22_20190613_00015.jpg

View of left wing wall with missing gasket. (2017)

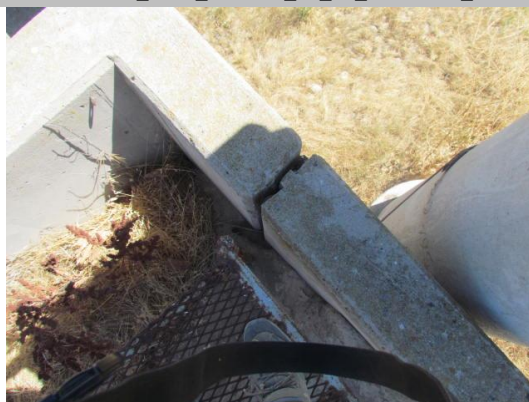
Photo 2 of 4 : ST_2019_NA0010_29_22_20190613_00016.jpg

Looking at left wing wall joint missing rubber gasket. (2017)

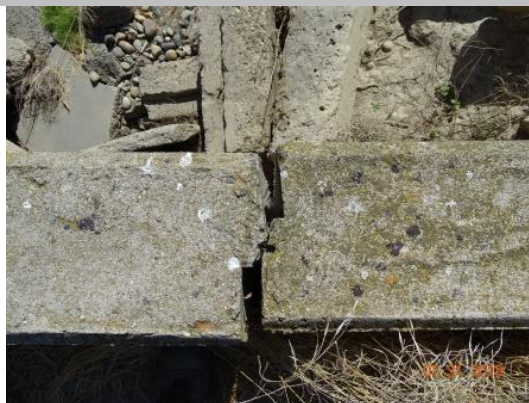
Photo 1 of 4 : ST_2019_NA0010_30_22_20190807_00013.jpg

Joint deterioration at left headwall. (2019)

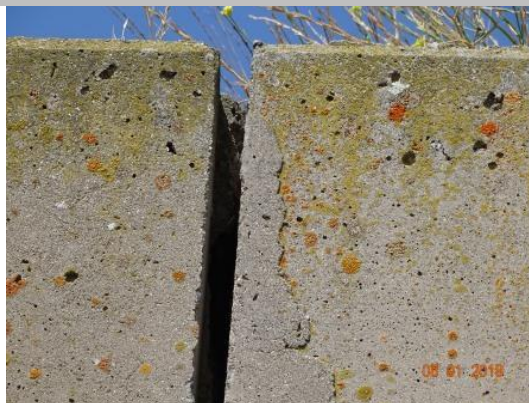
Photo 2 of 4 : ST_2019_NA0010_30_22_20190613_00006.jpg

Close up view of joint deterioration on left side of structure. (2018)

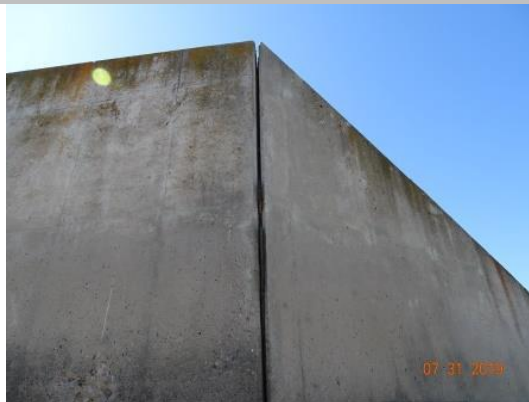
Photo 3 of 4 : ST_2019_NA0010_30_22_20190807_00014.jpg

Joint deterioration on left wing wall. (2019)

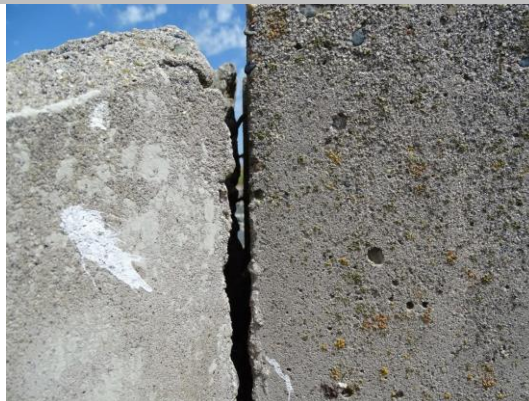
Photo 4 of 4 : ST_2019_NA0010_30_22_20190613_00008.jpg

Joint deterioration on left bank at wingwall (2017)

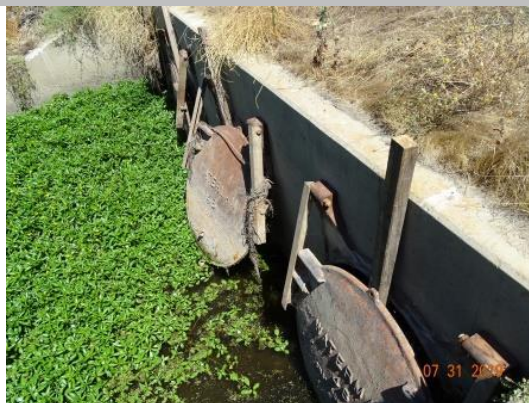
Photo 2 of 2 : ST_2019_NA0010_39_7_20190807_00016.jpg

View of outlet side of structure. Wood planks have been placed to prop open flap gates. (2019)

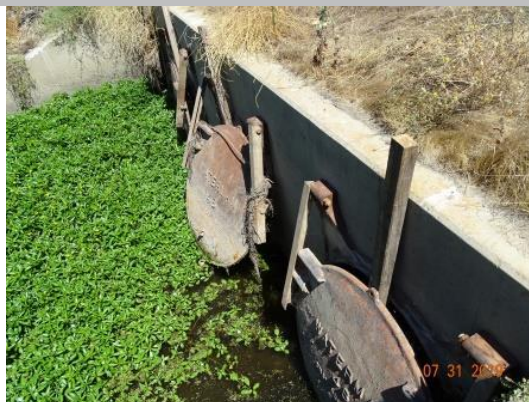
Photo 1 of 1 : ST_2019_NA0010_39_11_20190807_00017.jpg

Flap gates have been propped open using wood planks. (2019)

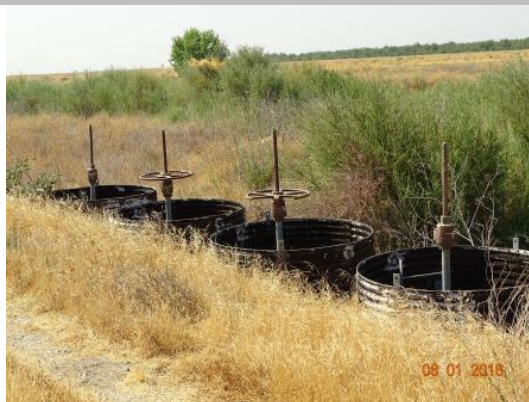
Photo 2 of 2 : ST_2019_NA0010_39_14_20190613_00010.jpg

View of missing and broken wheel handles. (2018)

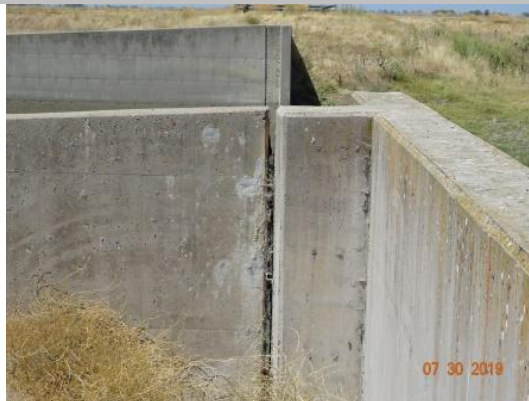
Photo 1 of 3 : ST_2019_NA0010_31_22_20190806_00013.jpg

View of left wing wall with deteriorated joint. (2019)

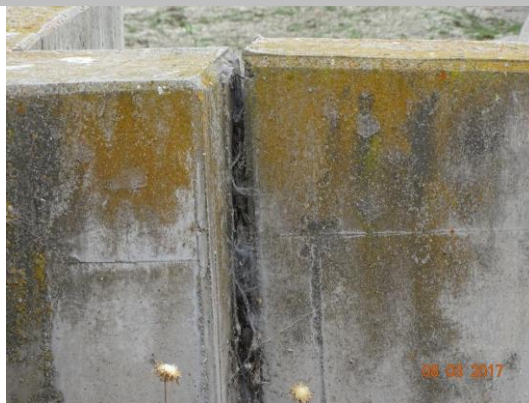
Photo 2 of 3 : ST_2019_NA0010_31_22_20190613_00005.jpg

View of right sidewall joint deterioration. (2017)

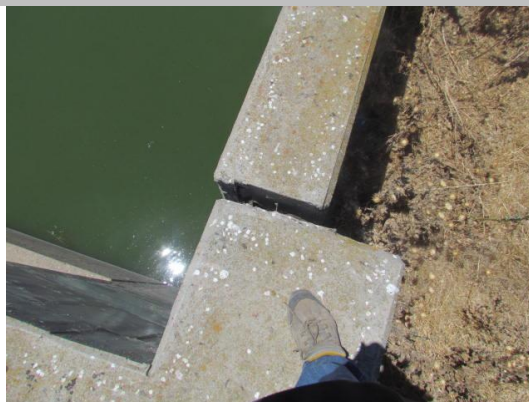
Photo 3 of 3 : ST_2019_NA0010_31_22_20190613_00006.jpg

Looking at right wing wall with missing rubber gasket in joint. (2016)

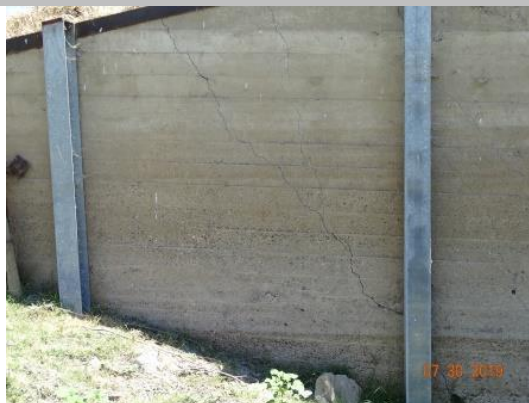
Photo 1 of 4 : ST_2019_NA0010_49_15_20190805_00028.jpg

Looking at small crack on right wing wall on downstream side of structure. (2019)

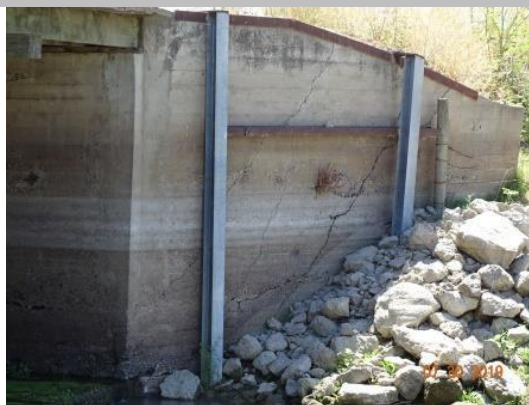
Photo 2 of 4 : ST_2019_NA0010_49_15_20190805_00029.jpg

Looking at crack on left wing wall on downstream side of structure. (2019)

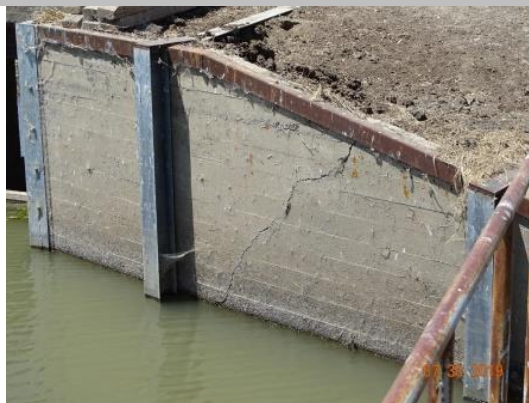
Photo 3 of 4 : ST_2019_NA0010_49_15_20190805_00030.jpg

Cracking on the right headwall of the structure. (2019)

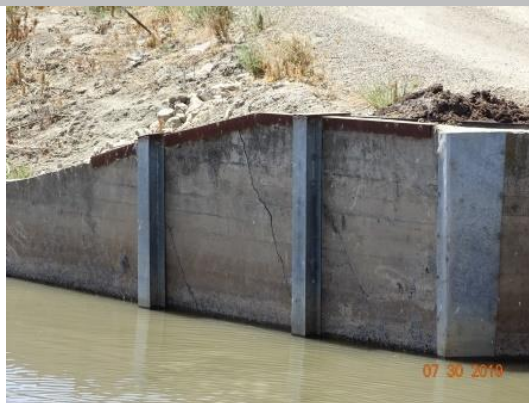
Photo 4 of 4 : ST_2019_NA0010_49_15_20190805_00031.jpg

Cracking on the left headwall of the structure. (2019)

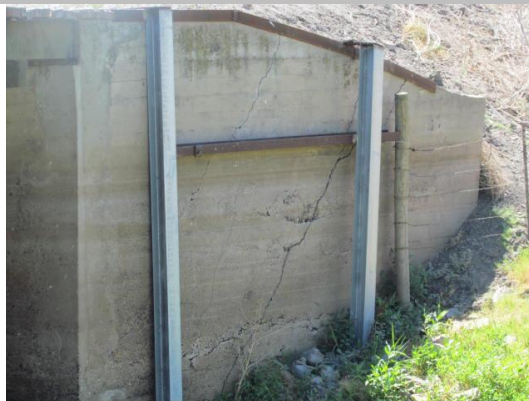
Photo 6 of 6 : ST_2019_NA0010_49_16_20190613_00020.jpg

Looking at repaired left wing wall on downstream side of structure.
Summer 2012

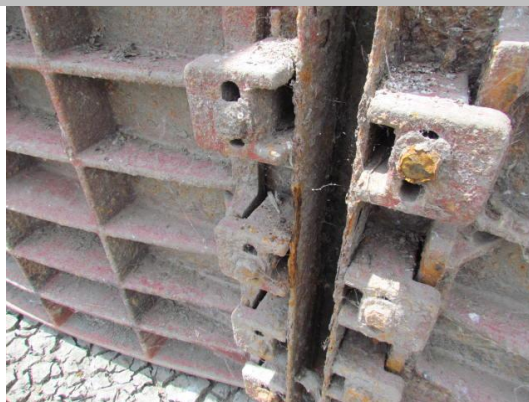
Photo 1 of 1 : ST_2019_NA0010_50_12_20190613_00005.jpg

Looking at corrosion on slide gates on upstream side of structure. (2015)

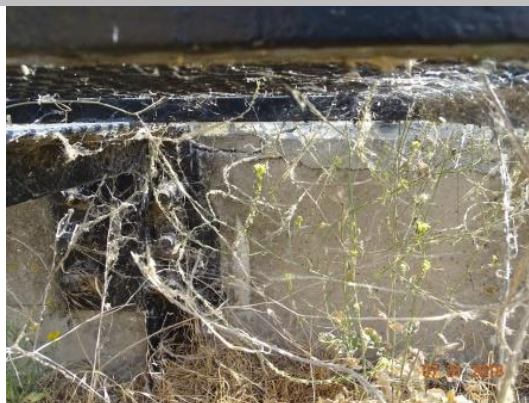
Photo 2 of 3 : ST_2019_NA0010_50_15_20190613_00008.jpg

Another view of the cracking on the headwall. (2018)

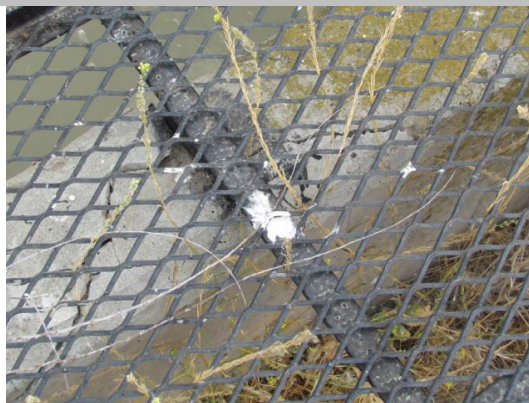
Photo 3 of 3 : ST_2019_NA0010_50_15_20190613_00009.jpg

Looking at cracks on headwall. (2017)

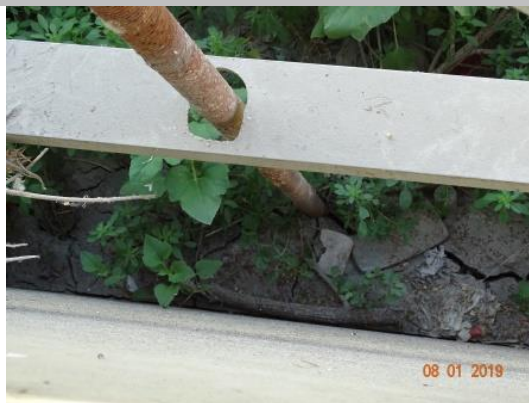
Photo 2 of 2 : ST_2019_NA0010_66_7_20190808_00026.jpg

Sedimentation built up above slide gate. (2019)

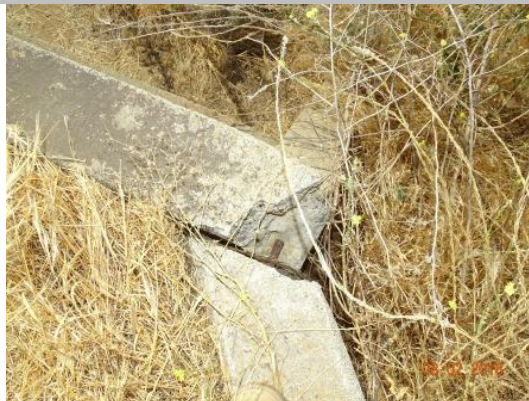
Photo 1 of 1 : ST_2019_NA0010_66_15_20190613_00016.jpg

View of cracking at the joint on the left inlet side. (2018)

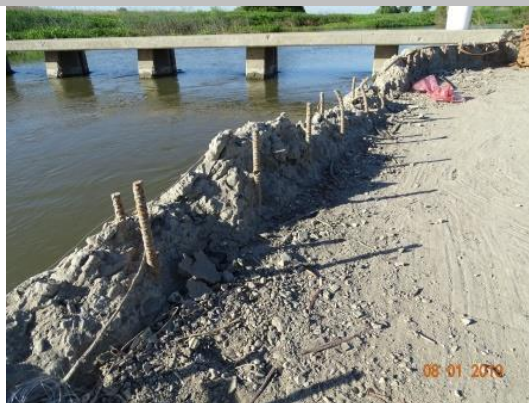
Photo 1 of 3 : ST_2019_NA0010_67_15_20190808_00009.jpg

Damage to left wall of structure. (2019)
